Project Name 18-03-9223 SLH 37-43 Grasmere Crescent Kendal LA9 6LP
Project Description
Start Date 08/03/2018
Project Status
Inspection Standard MSCC4 Sewers & Drainage (GB) (SRM4 Scoring)

CCTV Survey report & recommendations

We were instructed to conduct a CCTV survey to investigate if the drainage is the cause of the water logging at the rear of No 39.

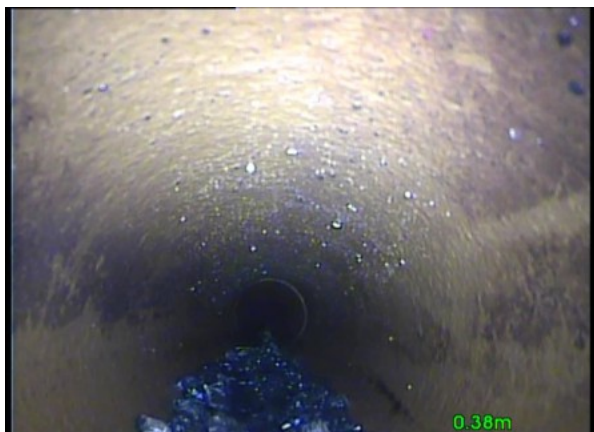
1, 00:00:11, 0.38m
Settled deposits, coarse, 5% cross-sectional area loss, start

Remove all settled deposits with Warthog nozzle

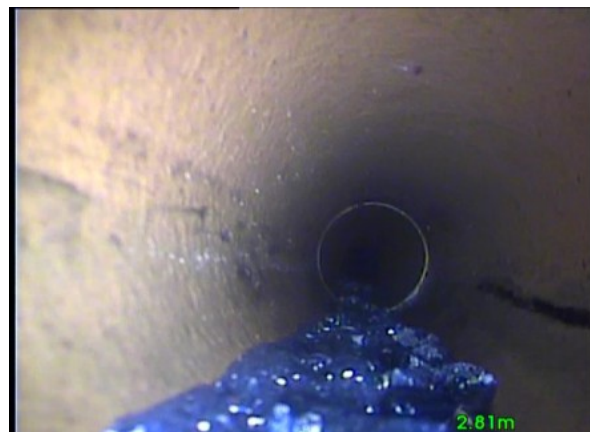
2, 00:00:25, 2.80m
Settled deposits, coarse, 5% cross-sectional area loss, start

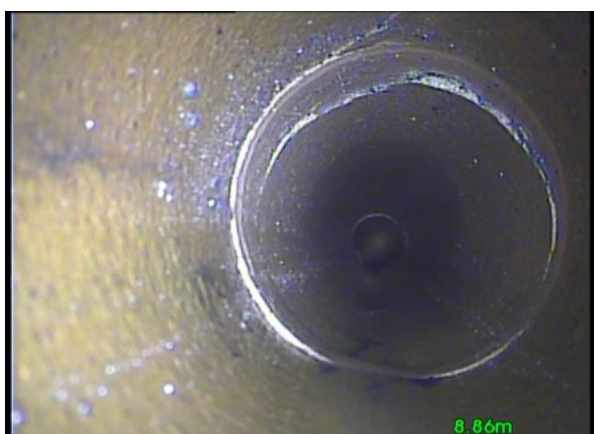
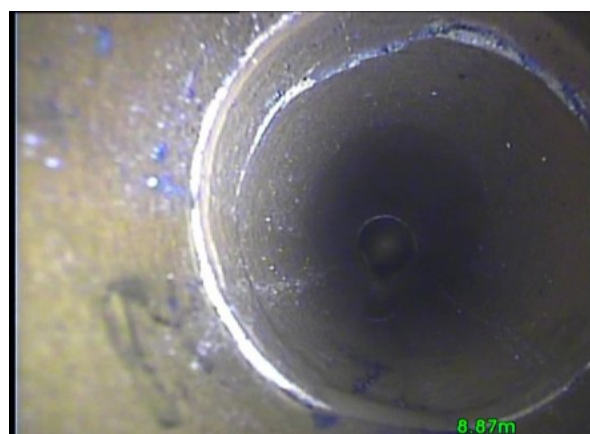
Section	Pipe Ref	Grade	Description
2	MH1X	3	Fracture, circumferential from 9 o'clock to 4 o'clock
3	MH2X	4	Hole in drain or sewer at 11 o'clock

3, 00:00:58, 8.86m
Fracture, circumferential from 9 o'clock to 4 o'clock

4, 00:00:58, 8.86m
Fracture, circumferential from 9 o'clock to 4 o'clock

Insert a 100mm x 600mm localised patch liner to repair fractured pipe

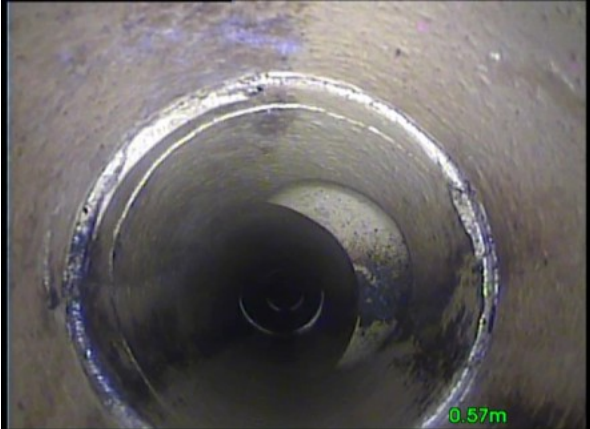
1, 00:00:17, 0.57m
Fracture, circumferential from 12 o'clock to 12 o'clock

Insert two 100mm x 1000mm localised patch liners

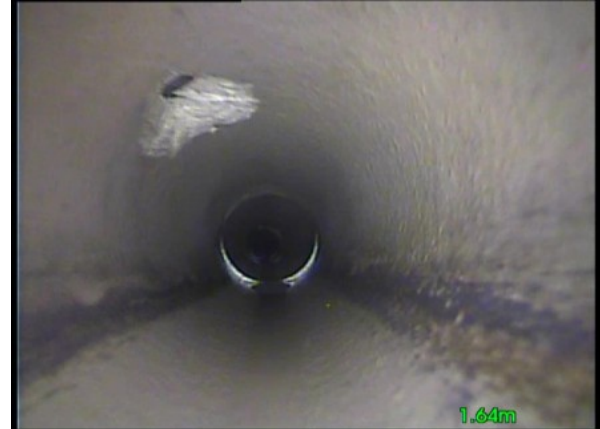
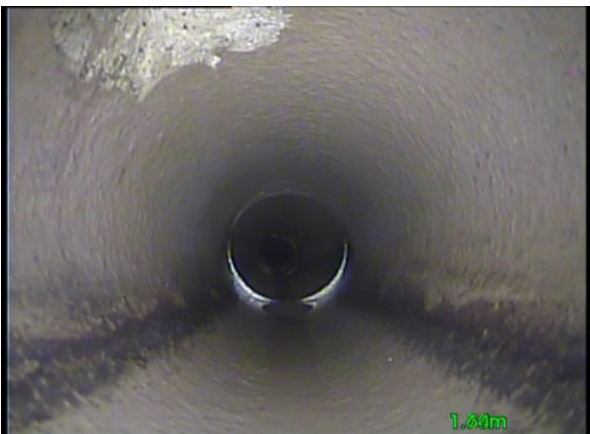
2, 00:00:22, 1.64m
Hole in drain or sewer at 11 o'clock

3, 00:00:22, 1.64m
Hole in drain or sewer at 11 o'clock
