Fire Risk Assessment

Property assessed:	9-10 Longlands View Kendal LA9 6HJ
Client:	South Lakes Housing
UPRN:	1101-2
Property Classification:	Level 3
Document Print Date:	07/02/2019

FRA Inspection Date:	28/09/2018
FRA Issued to Client:	07/02/2019
FRA valid to:	07/02/2022
FRA completed by:	Savills (UK) Ltd, 33 Margaret Street, London W1G 0JD T: 020 7409 8737 E: fireriskhousing@savills.com

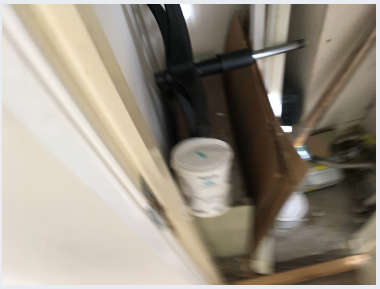
Question	G.2	Comment: Combustible items were noted close to an ignition source. First floor service cupboard was being used for resident's storage

Section	House-Keeping			
Action ID	171246			
Quantity - Known - Potential	 N/A N/A	Recommendation: All combustible items should be removed from the electrical intake cupboard and the door kept locked.		
Priority	Man1	Due Date: 07/03/2019	Status: Not Complete

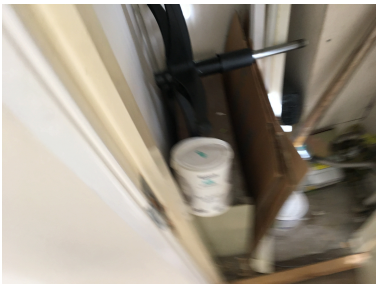
Question - G.2: Are combustible items kept clear from sources of ignition such as electrical equipment?	No
Comment: Combustible items were noted close to an ignition source. First floor service cupboard was being used for resident's storage	
Recommendation: All combustible items should be removed from the electrical intake cupboard and the door kept locked.

Priority: Man1	Known Quantity: N/A	Potential Quantity: N/A	Action ID: 171246
